Manhole Inspection Summary

Manhole # S29C__012MH

Location Address: **MARTIN LUTHER KING BLVD** Cross Street: **W FRANKLIN ST**

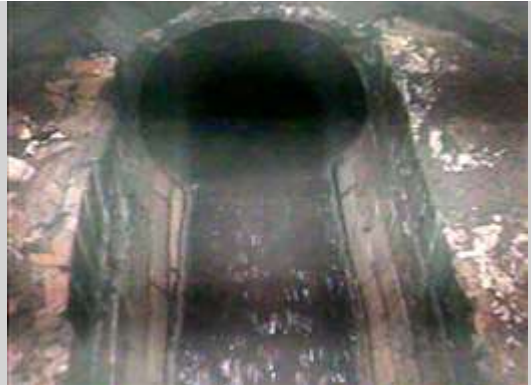
12 O'Clock Outflow

18 in. Circular Gravity Sewer
Pipe Out @ 12 O'Clock

Pipe Height: (in.) Direct
Pipe Material: **Clay** ☐ Pipe Lined
Invert Depth: **20.18** (ft.) Flow Characteristics: **Fast**
Deposits: ☒ None ☐ Mud ☐ Sludge ☐ Debris ☐ Grease
Silt Depth: (in.) Deposits Extent:
Infiltration: **None** Pipe Seal Cond: **Sound**

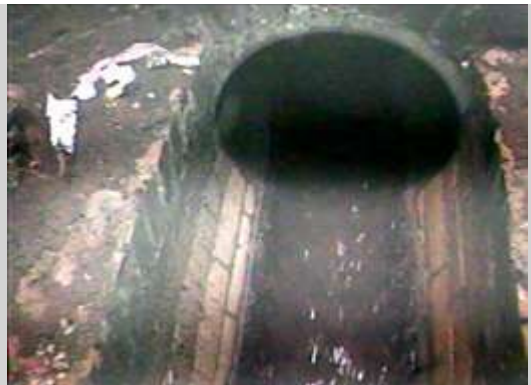
6 O'Clock Inflow

18 in. Circular Gravity Sewer
Pipe In @ 6 O'Clock

Pipe Height: (in.) Direct
Pipe Material: **Clay** ☐ Pipe Lined
Invert Depth: **20.16** (ft.) Flow Characteristics: **Fast**
Deposits: ☒ None ☐ Mud ☐ Sludge ☐ Debris ☐ Grease
Silt Depth: (in.) Deposits Extent:
Infiltration: **None** Pipe Seal Cond: **Sound**
